# AUDIO SERVICE

BULLETIN NO.: 07-81

DATE: August 1981.

SUBJECT: CR-2020

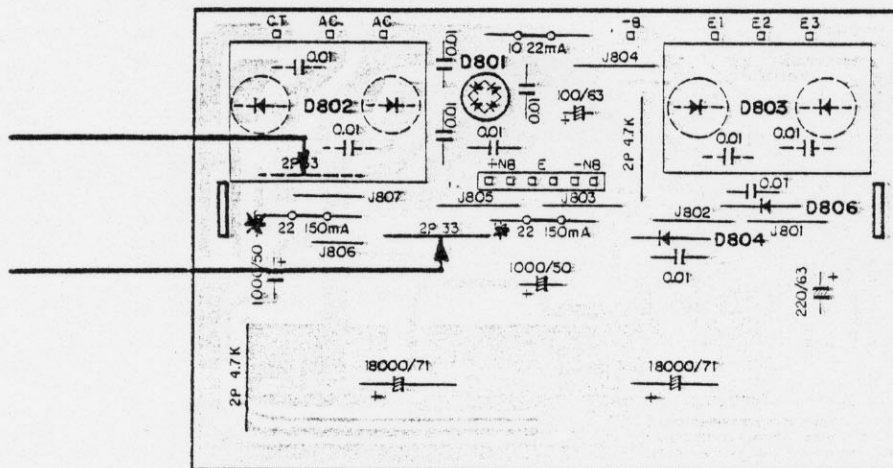
### ELECTROLYTIC CAP. C. BOARD

Problem: Intermittent power supply.  
Receiver goes on and off, speaker relay clicking.

Cause: R 801 and R 802 (33 ohm) in electrolytic capacitor circuit board get hot and unsolder themselves.

Remedy: Remove both resistors and install new 33 ohm, 3/4 watt wire wound resistors.

Mount the resistors approximately 1/4 inch away from the circuit board.

We suggest to use Ohmite #4374. These resistors are available from Yamaha Canada Music, Parts Department.

\* Also replace the 22 ohm 150 mA fuse resistors with Ohmite #4369 22 ohm 3/4 watt resistors.
